**UNDERWATER FACILITIES
INSPECTION AND ASSESSMENT
AT**

**NAVAL SUBMARINE BASE
SAN DIEGO, CALIFORNIA**

FPO-1-82(17) SEPTEMBER 1982

**COLLINS ENGINEERS, INC.
600 WEST JACKSON BOULEVARD
CHICAGO, ILLINOIS 60606**

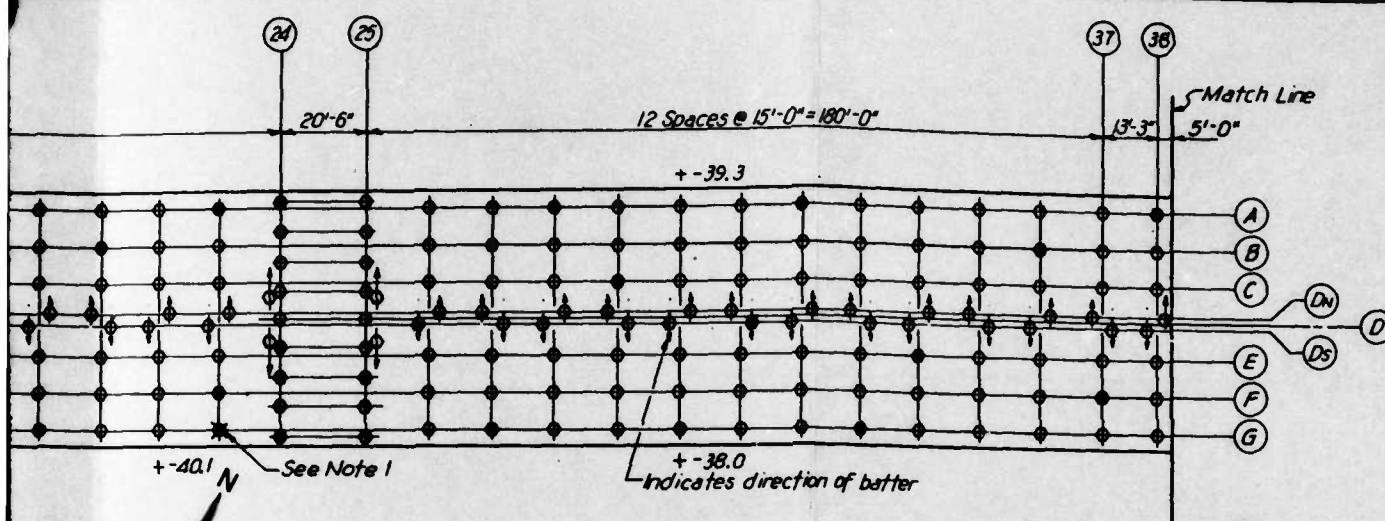
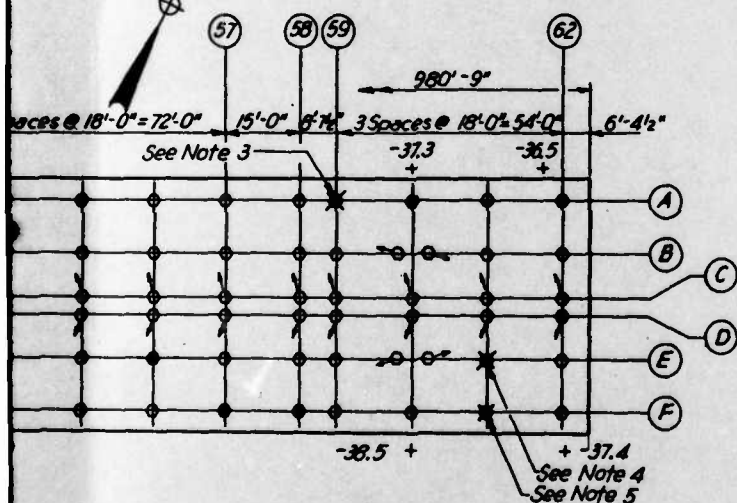
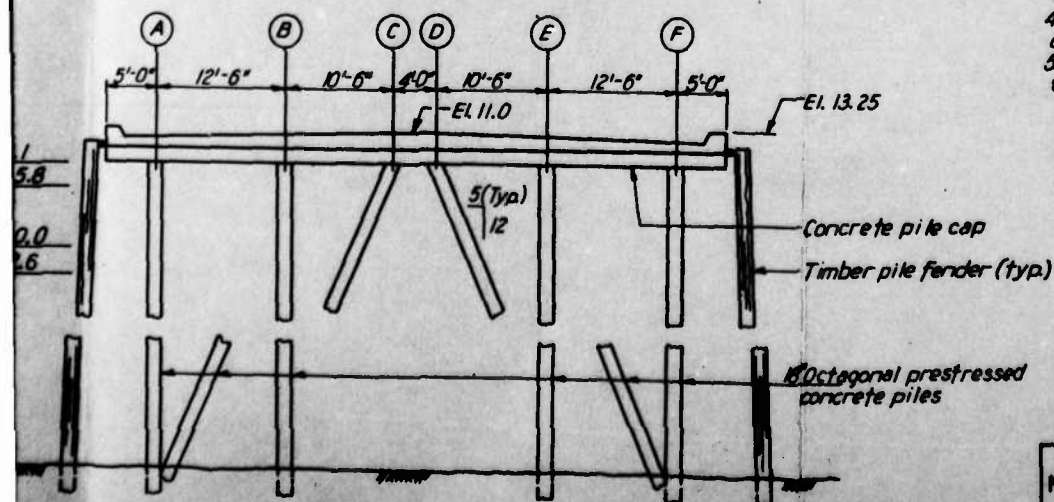
SECTION B-B

1. Pile concrete broken at connection to pile cap.
2. Pile broken off 6 ft. below MLLW.
3. Vertical crack in North face of pile; 1/2 in. wide from 15 ft. - 25 ft. below MLLW.
4. Vertical hair line crack in South face of pile; 3 ft. - 10 ft. below MLLW.
5. Vertical crack in South face of pile 1/2 in. wide; 5 ft. - 12 ft. below MLLW.

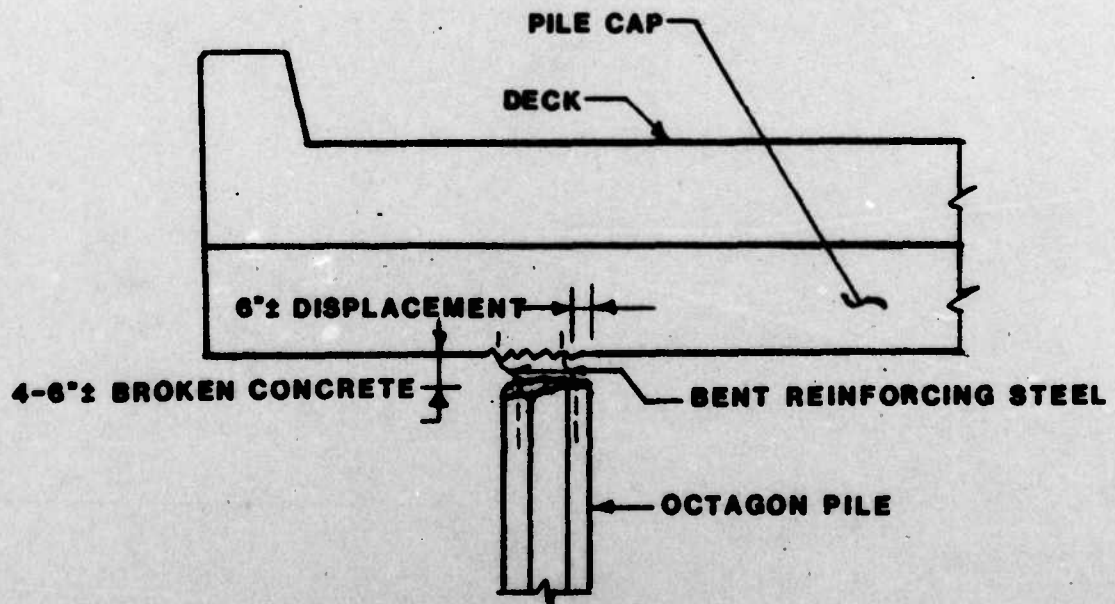
FIGURE 4

One severely damaged pile, however, was found. Pile 23G was damaged above water at the underside of the pile cap. The concrete of approximately the top six inches below the pile cap was broken and missing. The reinforcing steel in the pile was exposed and bent, but no steel was severed. Figure 4 below, in which only some of the steel is shown, illustrates the damage. No further damage was noted underwater.

PILE 23G

Pier 5000 is in excellent condition, except for the damaged Pile 23G. No other significant structural damage or deterioration of the pier was observed.

It is recommended that Pile 23G be repaired. One method of affecting that repair would be by removing a small portion of the concrete deck and pile cap in the area of Pile 23G; re-forming the concrete pile cap around the pile in its present position; installing additional reinforcing steel; and replacing the portion of the concrete deck that was removed. The repair of

the pile and pile cap might also be accomplished without the removal of the deck by working from a floating stage under the pier. Using either procedure, all work could be accomplished above water. It is estimated that this repair could be accomplished for approximately \$4,000.

It is recommended that no vehicle, equipment, or storage loads be permitted within approximately 20 ft. of Pile 23G until the pile is repaired.

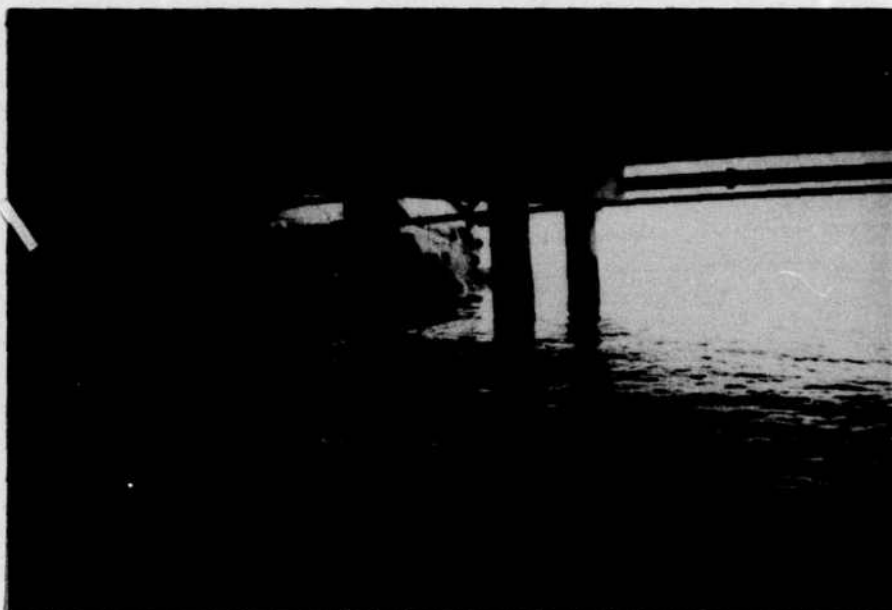
The prestressed concrete piles of Pier 5003 are in excellent condition. When cleaned of marine growth, the concrete appeared sound and the corners were sharp. Refer to Photographs 14 through 18 for views of typical piles.

PHOTOGRAPH 14 PILE BENT NUMBER 2, PIER 5003

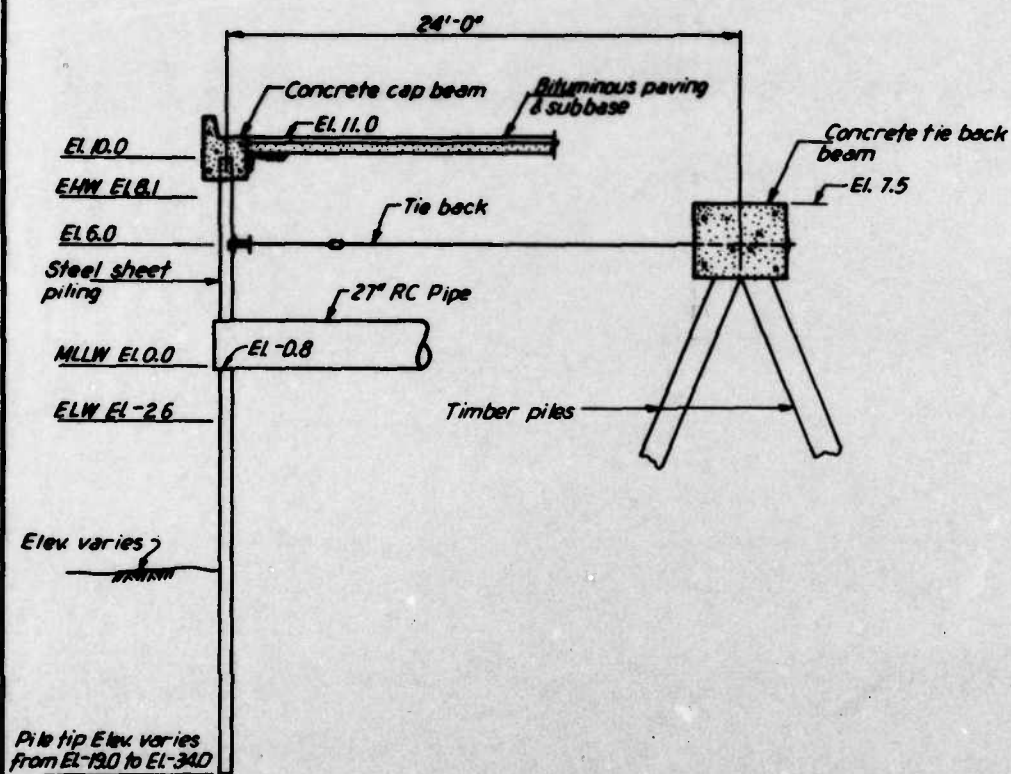
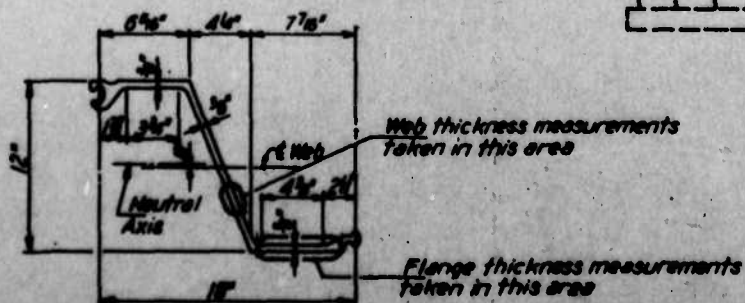
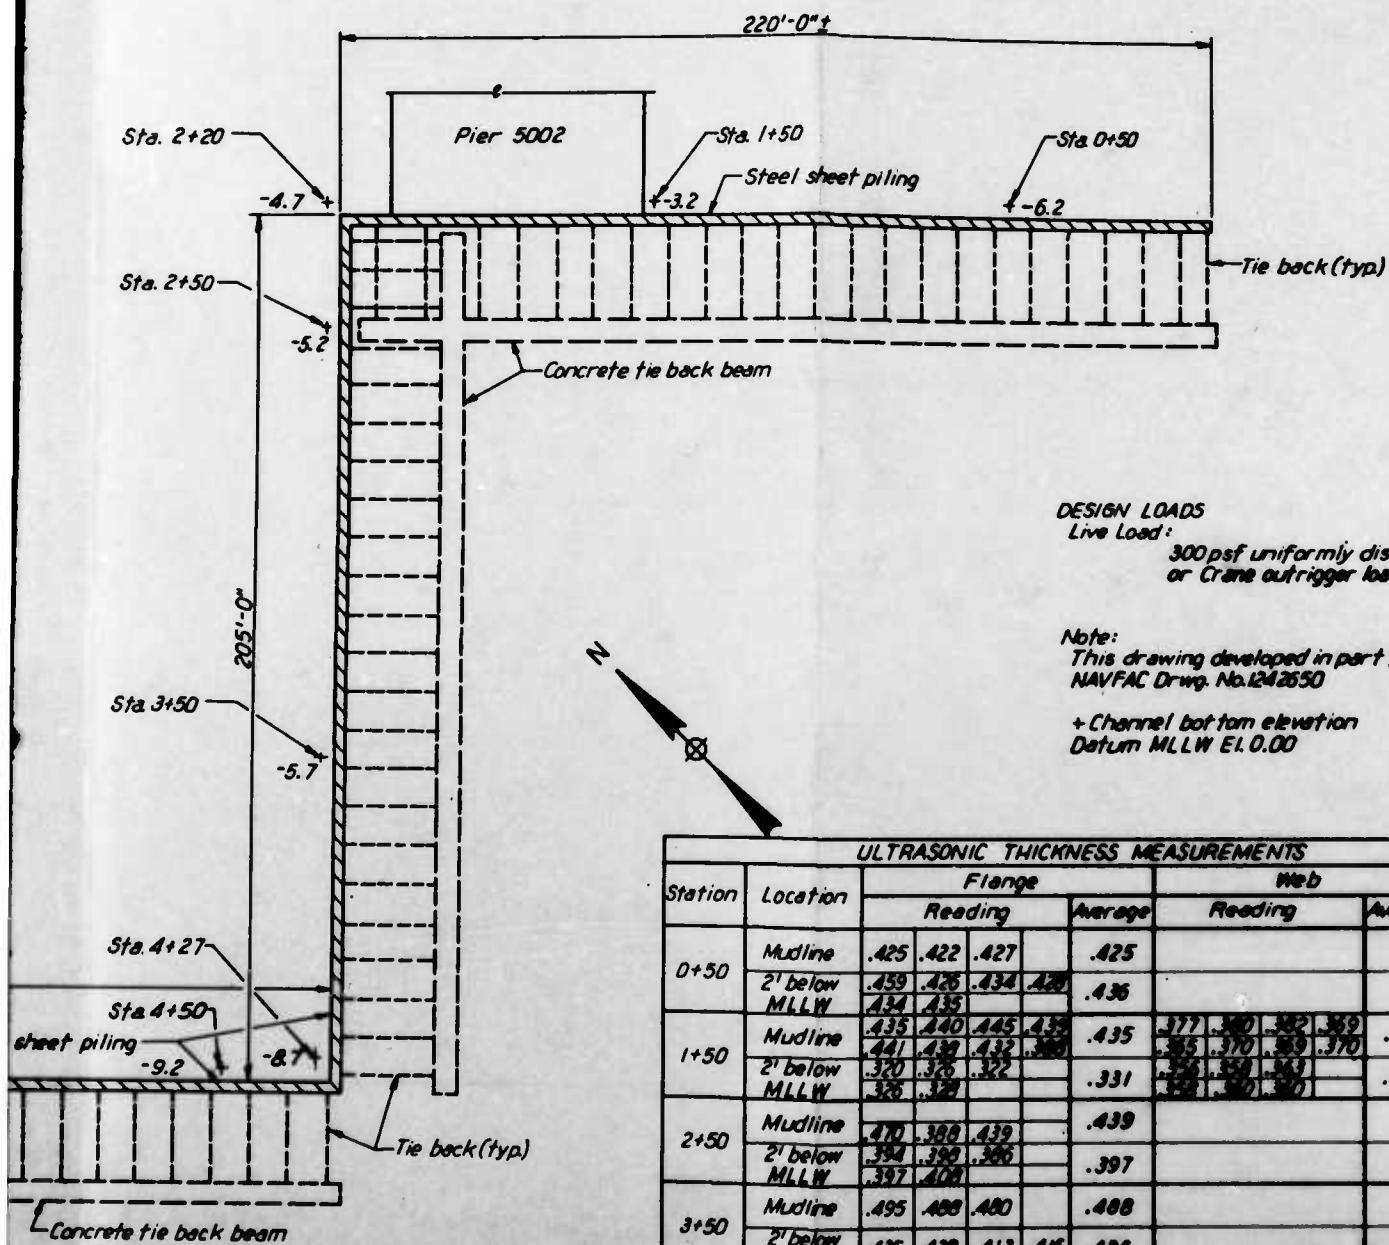
The remaining section of six steel sheet piles was measured ultrasonically. Refer to Figure 7 for the detailed measurements. In general, the thickness of the steel sheeting is greater than or approximately the same as the theoretical

The steel sheet pile bulkhead is in excellent condition below water. No significant damage or deterioration was found. Measurements in excess of the original theoretical thickness may be due to the variations in fabrication tolerances, the normal accuracy of the thickness measuring device, and the possibility of measuring thickness close to the pile interlock.

No immediate repairs are warranted at this time. It is recommended, however, that a protective coating be applied to the steel sheet piling, and exposed tie rods and nuts as a part of future preventative maintenance. The coating should extend from about low water to the top of the steel sheeting. As a part of the preparatory work, the steel components should be cleaned by sandblasting. The cleaning and application of the coating could be accomplished for approximately \$11,000.
